Bed V-2072 Overhead Valve PV505B Packing Failure

IPS Control: 1739459

Location: Hydro,
South Isomax, PSA Unit

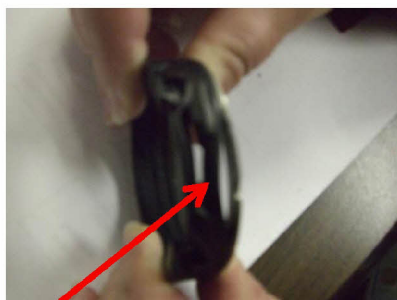
Holes in worn PV505B valve packing

2. The leaking valve was carefully disassembled to confirm it was within all OEM specifications and had the correct packing. However, the packing was worn through and the stem was slightly worn.

3. This style of valve and actuator is designed to operate for 500,000 strokes. The PV505B was last serviced in March 2006 when all 25 valves at the PSA Unit were serviced. This corresponds to 43 months or about 1,500,000 strokes when the PV505B packing leaked.

1. Install warning tags on PSA valves to contact analysts prior to performing maintenance and follow [special procedures for these types of valve packing](#).
2. Keep at least one full set of 5 valves in inventory to minimize downtime and the cost of similar future failures.
3. Adjust replacement frequency of PSA bed sequencing valves based on expected reliability and failure rates.

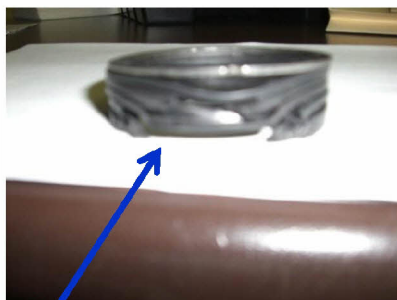
Compressed Enviroseal packing
